Parts & Service Bulletin

Model: Alley Gator with Zero Radius Arm

Subject: Arm Maintenance

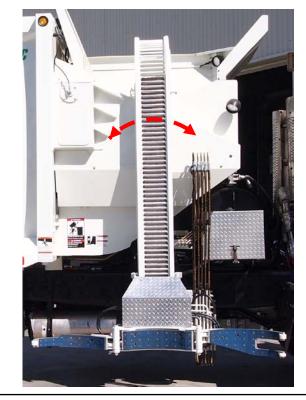
• **Arm sway:** With the arm out one to two inches (1" - 2") from the home (parked) position, check for sway by pushing the arm mast forward and rearward. If the arm sways more than one-half inch (1/2") in either direction at the upper arm bumper stop, the slide rollers must be adjusted - refer to the adjustment procedure included.

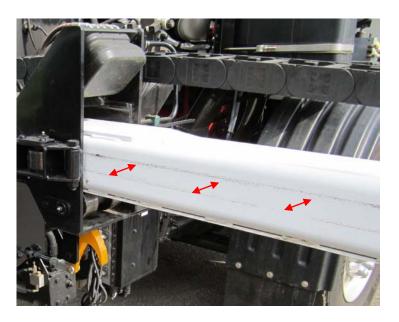
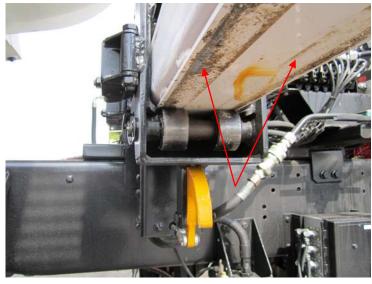
• Arm slide tube: Extend the arm fully, then clean and inspect the arm tube sides and bottom. The roller tracking areas must be free of dirt, grease and oil, and the roller tracking area must not be worn more than three thirty-seconds of an inch (3/32") at its deepest area. If any area of a roller track on the slide tube sides is worn deeper than three thirty-seconds of an inch (3/32"), the arm slide/mast weldment must be replaced. If any area of a roller track on the slide tube bottom is worn deeper than three thirty-seconds of an inch (3/32"), the roller wear plate must be replaced.

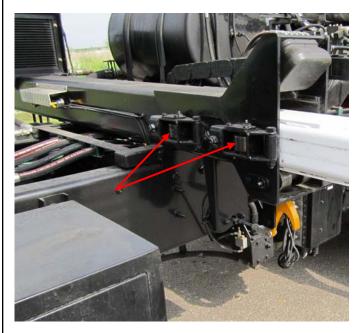
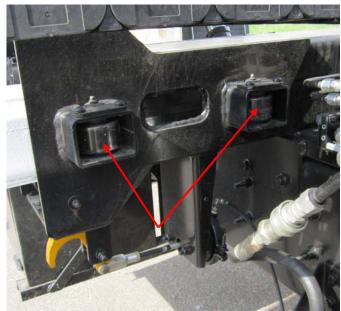
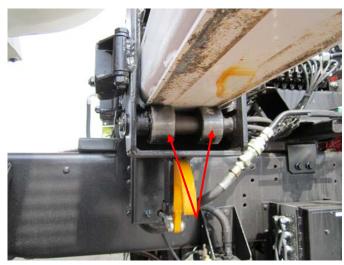
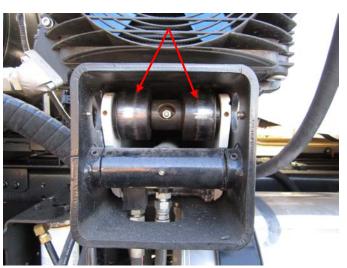
• Slide rollers, eight (8) total: Fully clean and inspect the outer face of all rollers. Check the complete roller face by placing the arm slide in multiple positions; they must be free of dirt, grease and oil, with no cracks or flat spots evident. The roller must turn without any wobble or binding during arm travel. Replace any roller exhibiting wear or damage. Lubricate the rollers, paying particular attention to not over-grease them; grease until lubricant is just visible between the roller case and the inner race.

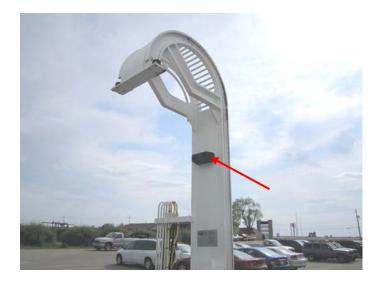
Arm stop bumper pads: Check both the upper and lower arm stop bumper pads for wear, cracking or damage; replaces as necessary. With the arm fully retracted, both arm stop bumper pads must be compressed at least one-quarter inch (1/4"); the pads may be adjusted by shimming.
