**Model:** Leach Rear Loaders

**Subject:** Proper Carrier Roller Adjustment & Maintenance

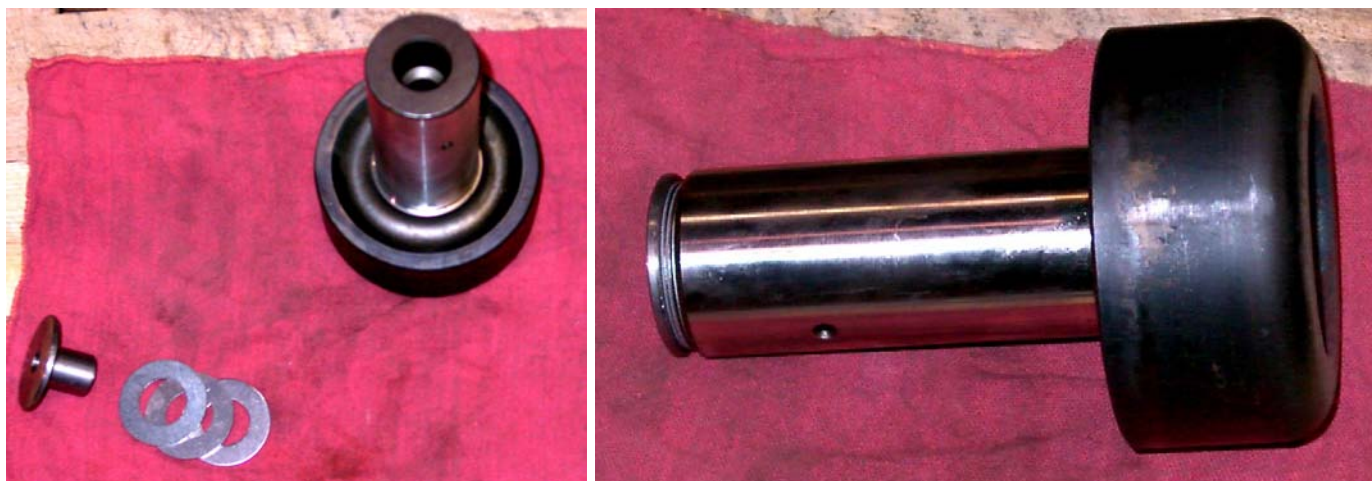
When replacing a roller, always use the same amount of shims as originally produced; however re-shimming is usually required upon packer or carrier panel replacement. The rollers are to be adjusted by the use of shims (LabriePlus part number 100179) placed behind the roller, on the spacer cap (LabriePlus part number L100163). This will allow the roller to either be moved outward by the addition of shims, or moved inward by the subtraction of shims. It should be noted that the shims and spacer cap are used only as required; there is no set amount of shims per roller.

The rollers align the carrier by means of slight contact with the inside vertical face of the track channels (also known as the “web” of the track), and should never be allowed to apply excess force to the point of distorting the web. Over shimming of the rollers will result in track distortion. The preferred condition of rollers is to allow them to have a minor amount of side travel in the tracks rather than their being too tight. Proper shimming of the rollers will avoid costly damage to the structure of the tailgate.

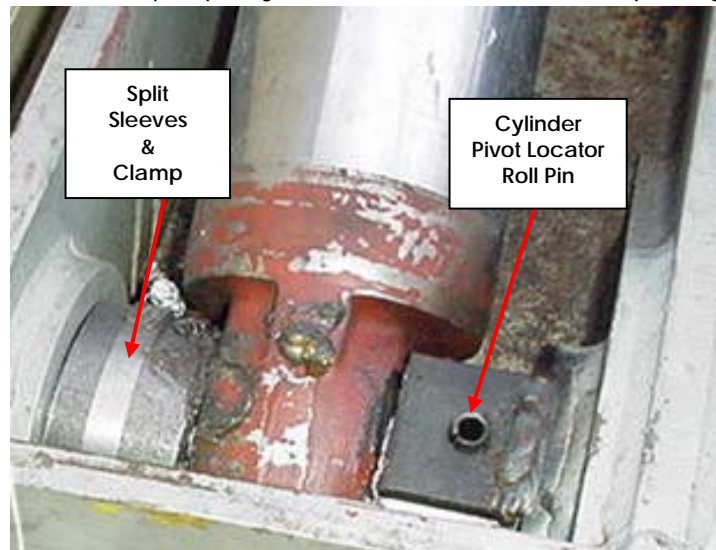
- Rollers (LabriePlus part number 100171) – check the rolling face for damage, flat spots or excessive wear.
- Roller bushings (2R-II, 2R-III LabriePlus part number L100189; Alpha, Alpha-III LabriePlus part number 100159) – check to ensure that the bushings are not worn to the point of allowing the roller to wobble.

- Carrier cylinder pivot (2R-II, 2R-III only, LabriePlus part number L100157) – check to ensure that the bushings are not worn to the point of allowing the roller to wobble. Check to ensure the pivot is correctly located. Check for excessive wear at the carrier cylinder rod eye.

- Carrier cylinder pivot locator roll pin & split sleeves/clamp (2R-II, 2R-III only, LabriePlus part numbers 102577, 100162, QUC00890) – Ensure that the roll pin is properly located through the locating tab into the carrier cylinder pivot. Check to ensure that the split sleeves are properly located and the clamp is tight.
