Model: All With Labrie Right Side Drive Cab Modification

Subject: Throttle Pedal Circuit Modification

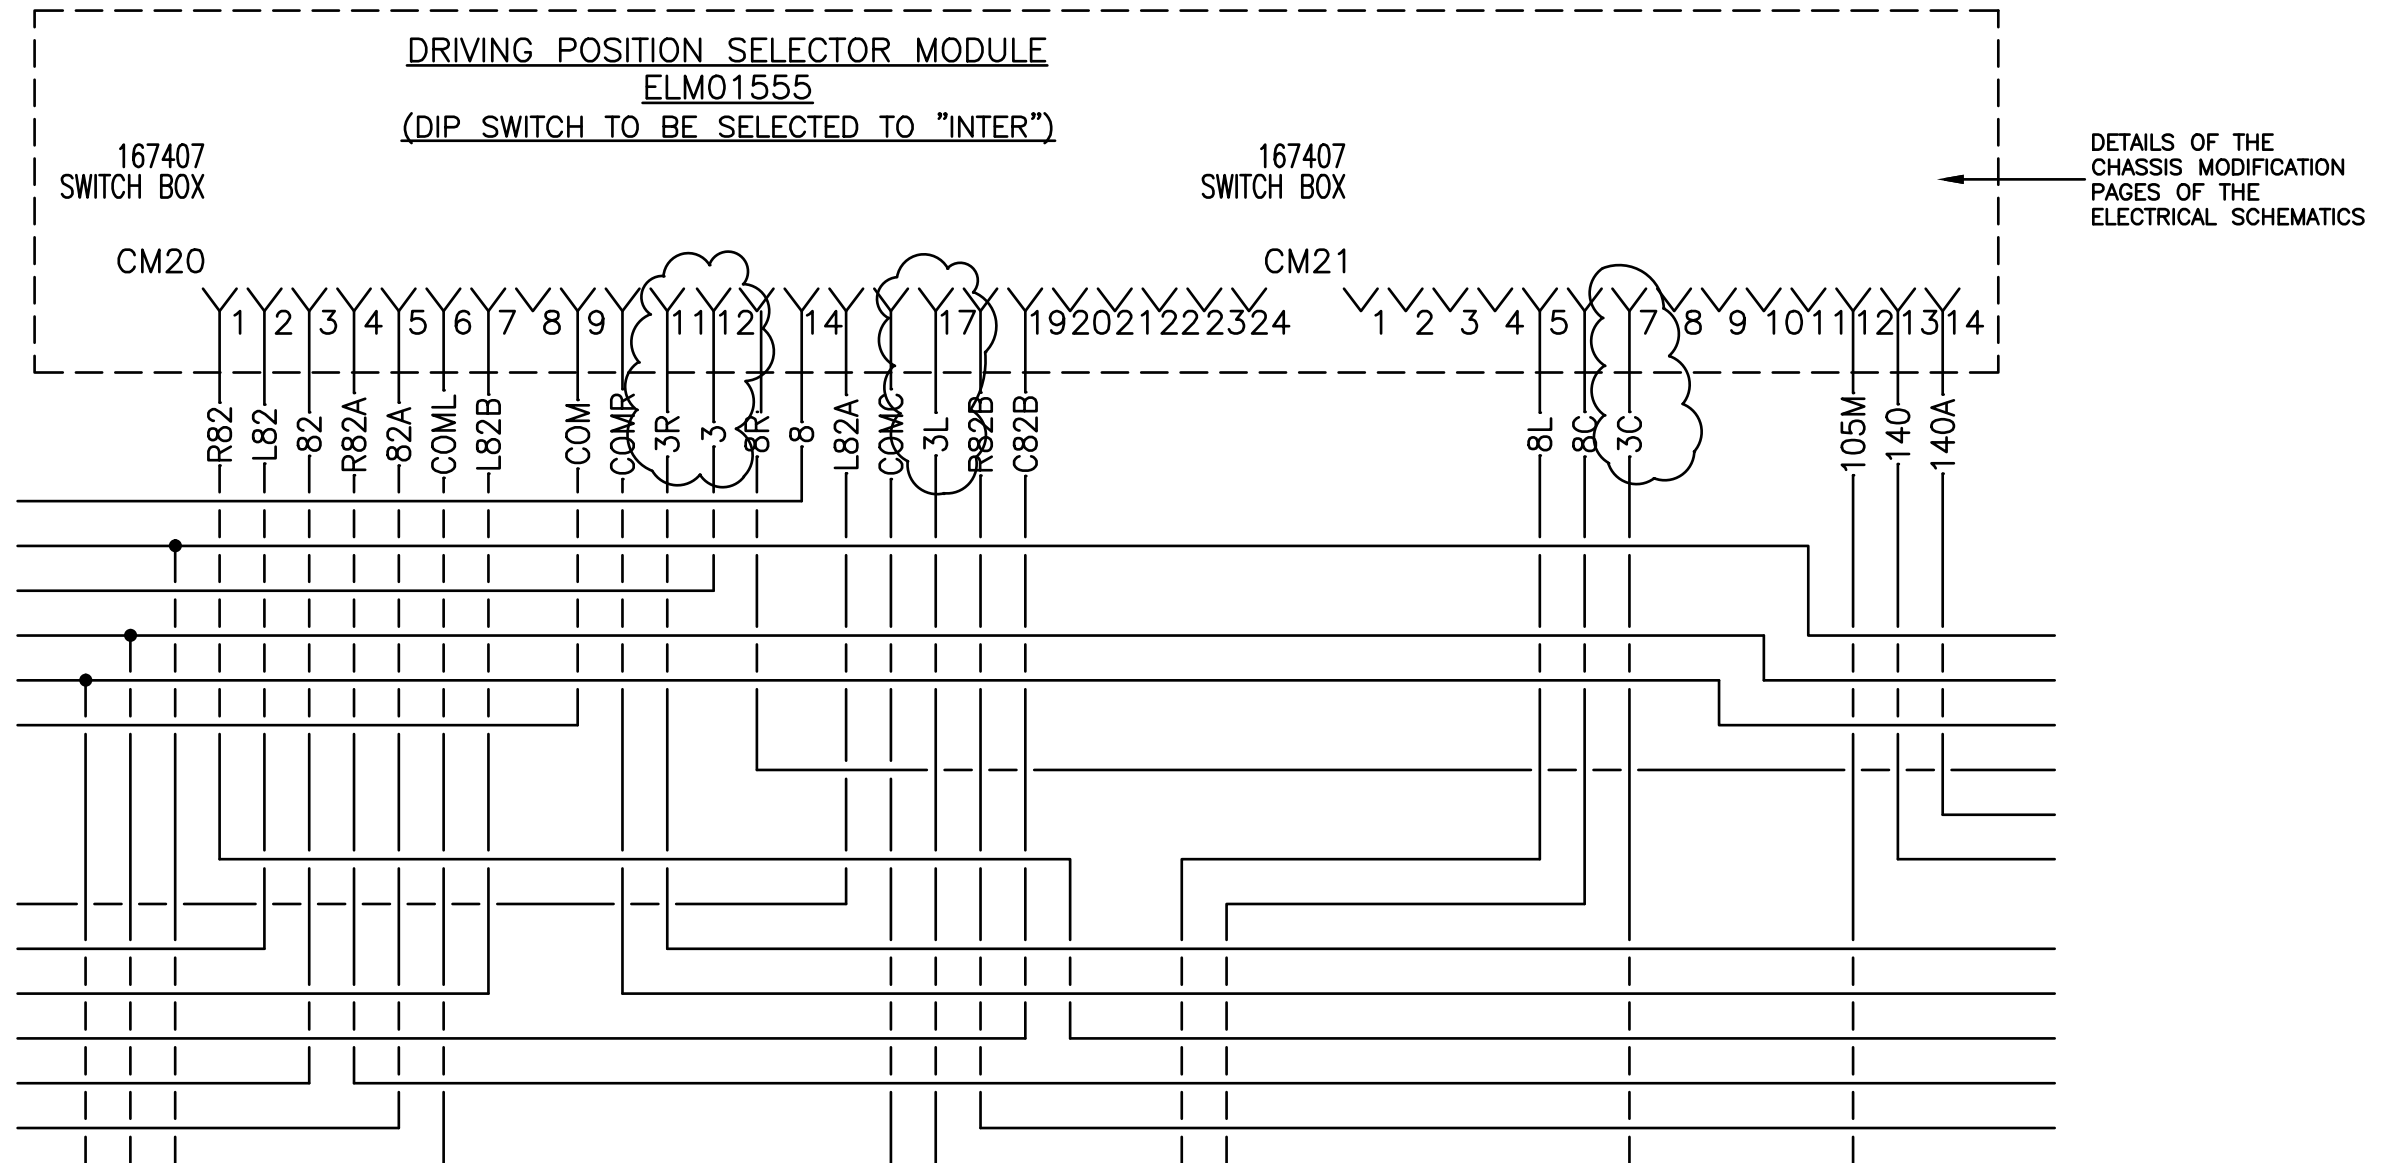
**Replacement Throttle Pedal Wire
Modification**

When replacing this part on a unit manufactured prior to the change, a chassis TPS fault code may be displayed. If this occurs, the throttle pedal circuit wiring must be modified to accept the revised component. The attached illustration describes the required modification.

HARNESS MODIFICATION

- 1) REMOVE IN CM20: WIRES 3R PIN 11, 3 PIN 12, 3L PIN 17
REMOVE IN CM21: WIRE 3C PIN 7
- 2) SPLICE THE 4 WIRES TOGETHER
