From: LabriePlus Service

Subject: Tailgate cylinder Orifice

#23-12

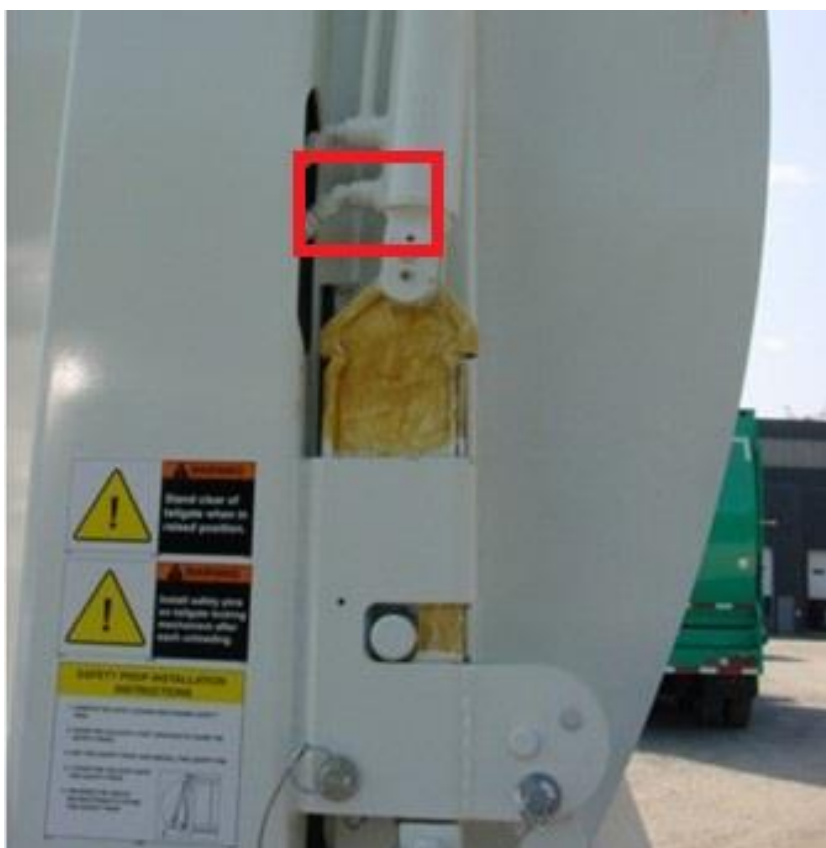
Our HD tailgate cylinder HYC00323 utilizes orifice fitting p/n-10384. This orifice is installed in the fitting closest to case end of the cylinder. (See picture below, fitting highlighted in red).

If you have the HD tailgate cylinder HYC00323 installed, and it is leaking out of the case end orifice fitting it is likely that the longer version of orifice p/n-10384 was installed. To rectify the issue, replace p/n-10384 orifice with orifice fitting p/n- HYF05120 and #08 JIC fitting p/n 217102.

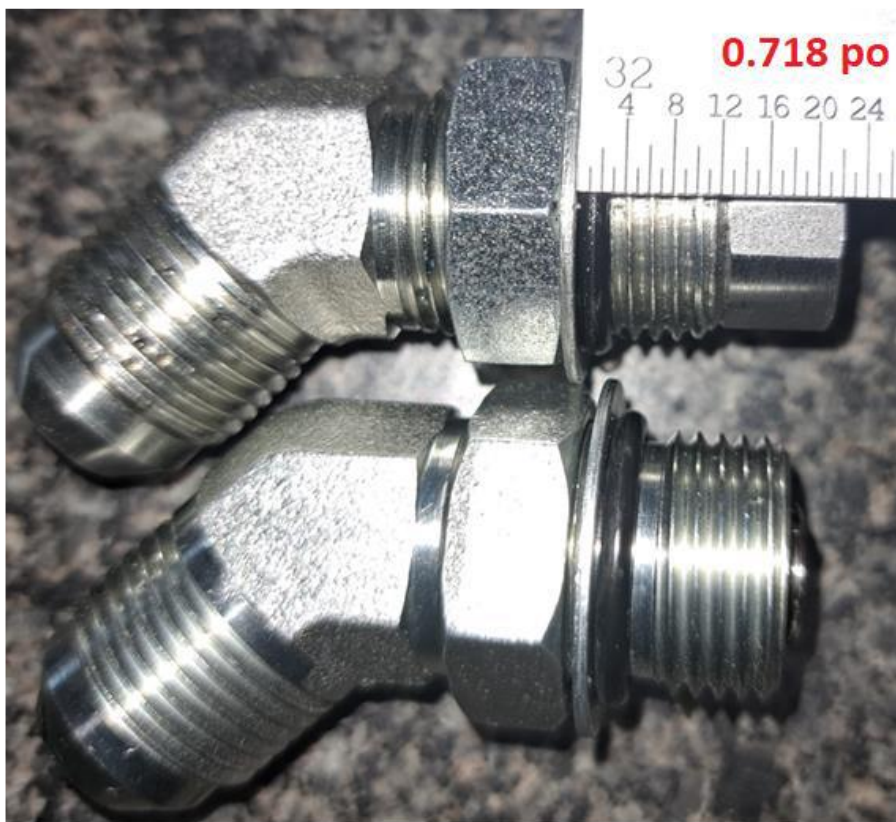
We have identified that there are two different versions of the p/n-10384 orifice fittings that vary in seating depth. Either dimensional orifice will work in standard TG cylinder HYC00320-04, however, only the shorter version of the orifice fitting will work in tailgate cylinder HYC00323, which is a heavier duty cylinder used on CNG powered units.

(See pictures below depicting both styles of orifice fitting p/n-10384).
